RAYMOND SERVICE INFORMATION

RSI CTB-18-007
November 28, 2018

Models
4250 S/N 50501 Up w/5K TT Mast
All 4250 S/N 55501 Up w/TT Mast

SUBJECT: Carriage Stop Replacement

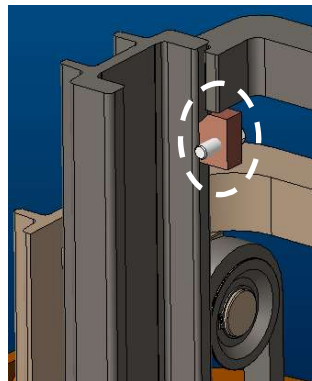
Figure 1

SERVICE INFORMATION: If existing carriage stop bolt is bent or broken, replace it with new carriage stop plate P/N 1270906 per the following procedure:

1. Raise the mast slightly to gain access to the upper portion of the inner telescopic.
2. Block the mast. Turn the key switch OFF and disconnect the battery connector.
3. Take measures to protect mast components from grinding and welding operations.
4. Remove damaged stop bolt and existing "welded on" block. See **Figure 1**.

NOTE: Do NOT use a cutting torch – grind off only.

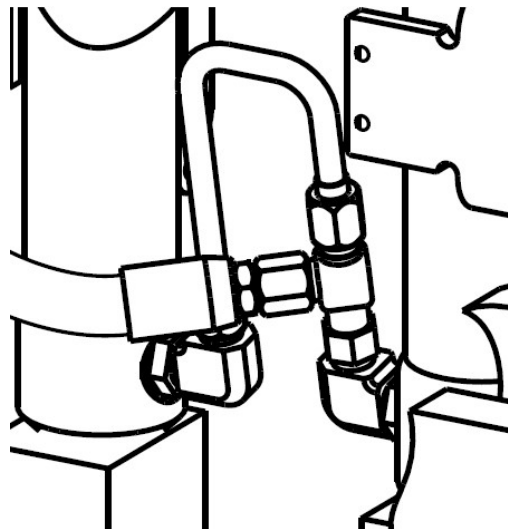
GENERAL INFORMATION: The trucks referenced above may stage incorrectly when lifting in temperatures below 70°F when using standard oil (P/N 990-616). A larger sized crossover tube and fittings is available. The most likely OACH's where this may occur are 83 to 88 inches, however, the new hardware can be installed on all TT mast OACH's.

SERVICE INFORMATION: Replace crossover tube P/N 1216820/001 with P/N 1297428/001 along with the associated hose and fittings (see Figure 1 and Table 1). The required hose is based on OACH (see Table 2).

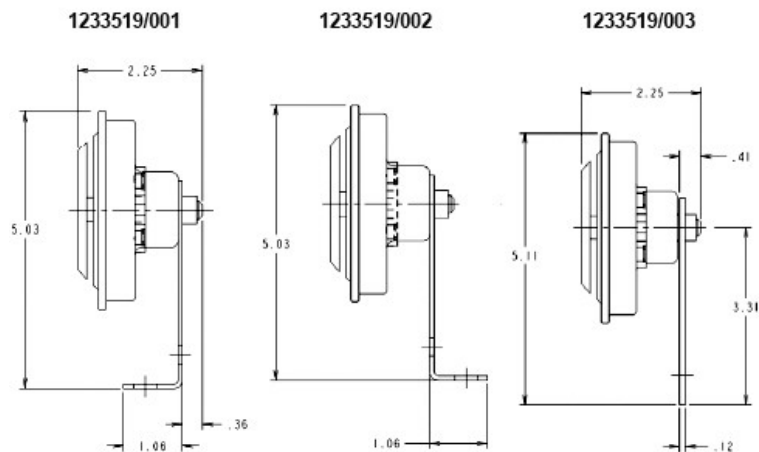
GENERAL INFORMATION: A new horn (P/N 1233519/XXX), designed to perform better in cold storage environments, is available to replace horn P/N 1047433/XXX.

SERVICE INFORMATION: Order and install P/N 1233519/XXX. Refer to Figure 1 for correct bracket configuration.

Connect Horn(+) and Horn(-) wires to the new horn. Make sure the horn bracket is isolated from the truck frame.

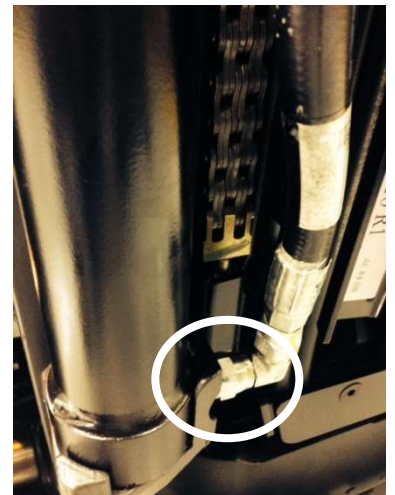
GENERAL INFORMATION: A removal and installation procedure for the Quad Mast Flow Control Valve was not included in the maintenance manual.

1. Tilt mast forward completely.
2. Lower carriage completely.
3. Turn key switch OFF and disconnect battery.
4. Place a small pan under the Flow Control Valve.
5. Remove the hose attached to the Flow Control Valve.
6. Remove the Flow Control Valve.
7. Install new fuse and torque to 44 to 48 ft. lb. (60 to 65 Nm).
8. Re-attach hose and torque to 44 to 48 ft. lb. (60 to 65 Nm).
9. Bleed the hydraulic system.
10. Test lift function and check for leaks.

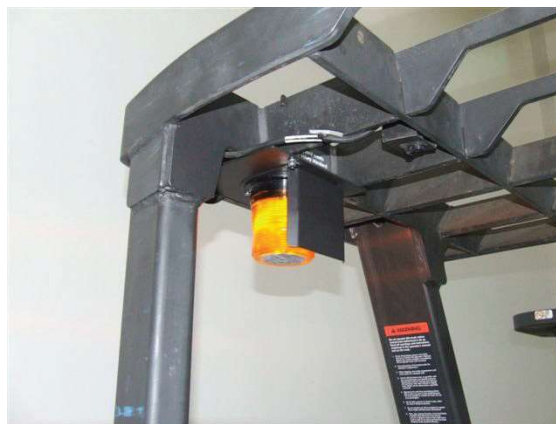
Figure 1

GENERAL INFORMATION: One of the application considerations relative to the use of the special feature Warning Light is that it may distract or annoy forklift operators. In certain applications, the Warning Light must be mounted under the overhead guard. For those applications, the installation of a deflector may assist in reducing the distraction and annoyance to the forklift operator caused by the Warning Light.

SERVICE INFORMATION: The deflector mounts between the Overhead Guard and Warning Light. See **Figure 1**. Order and install P/N 1142959 using original hardware.

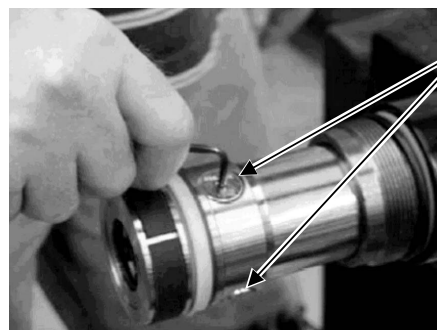
Figure 1

DESCRIPTION: It has been identified that some Quad Masts may experience drift due to the check valve(s) in the right-hand main lift cylinder becoming loose.

Check Valves (qty. 3)

1. Remove the right-hand main cylinder and remove the piston from the cylinder.
2. Remove check valve. See Figure 1.

3. Inspect check valve. If the O-ring is blown off or appears damaged, replace the check valve (P/N 223-001-569/L14).
4. Clean check valve and apply thread-locking compound P/N 990-403 to thread circumference of check valve.

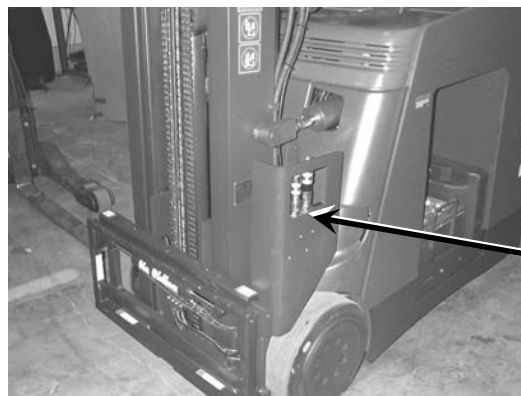
Quick
Disconnects
With Guard

DESCRIPTION: Damage may be caused to quick disconnect fittings/auxiliary manifold when maneuvering in a trailer or an overseas container. Operators may be able to catch the quick disconnect fittings on low overhead doors or trailers either in forks first direction (with no load backrest or a short attachment) or in tractor-first direction when elevated.

PROCEDURES: Order (P/N 223-001-802/102). See attached picture and install using original hardware.
