harman/kardon

Model FL8300

5 Disc Compact Disc Changer

SERVICE MANUAL

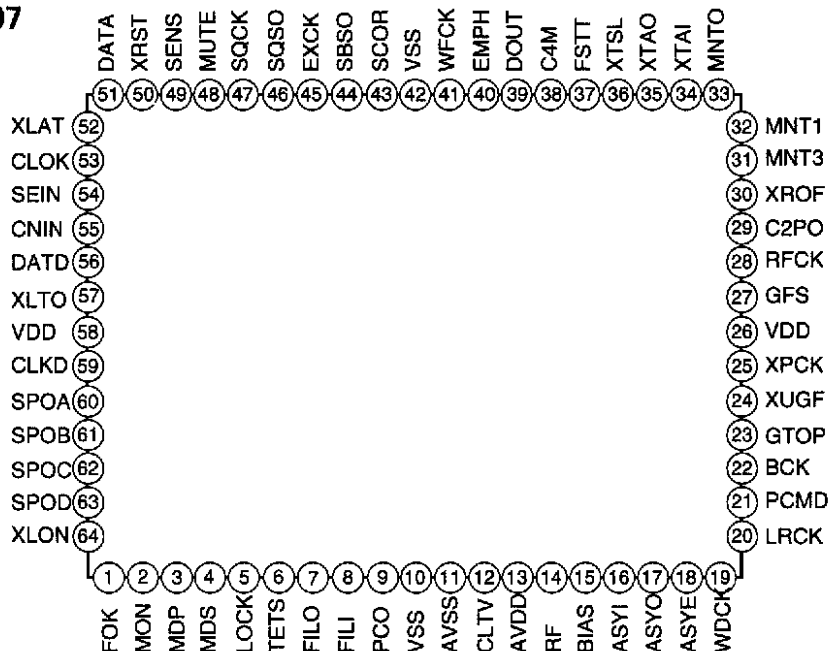
1. Pin Diagram

CXD 2607Q : IC107
