MASSEY FERGUSON

MF 4600

Series Tractors

SERVICE MANUAL

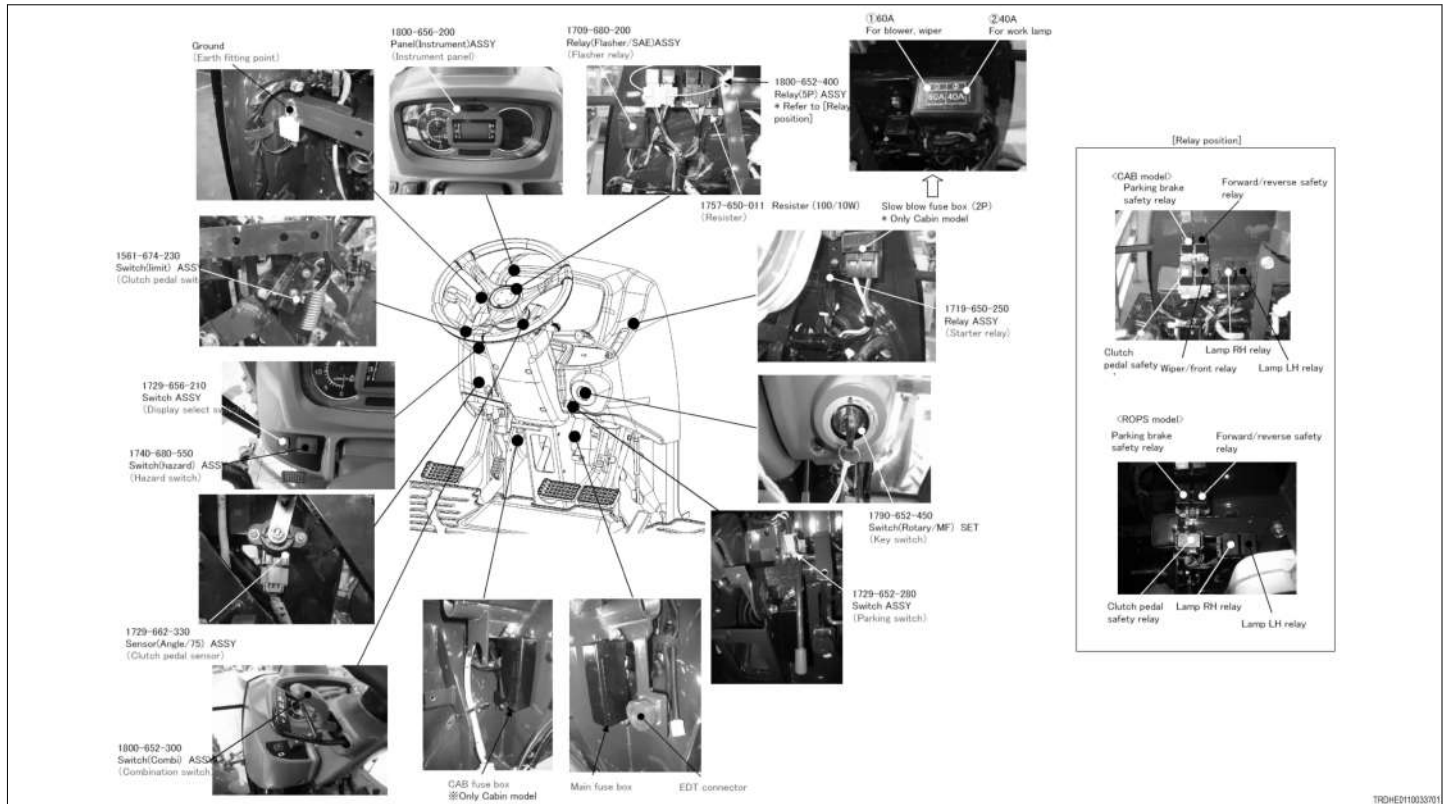
Fig. 17

7.4.5 Instrument panel switch location diagram

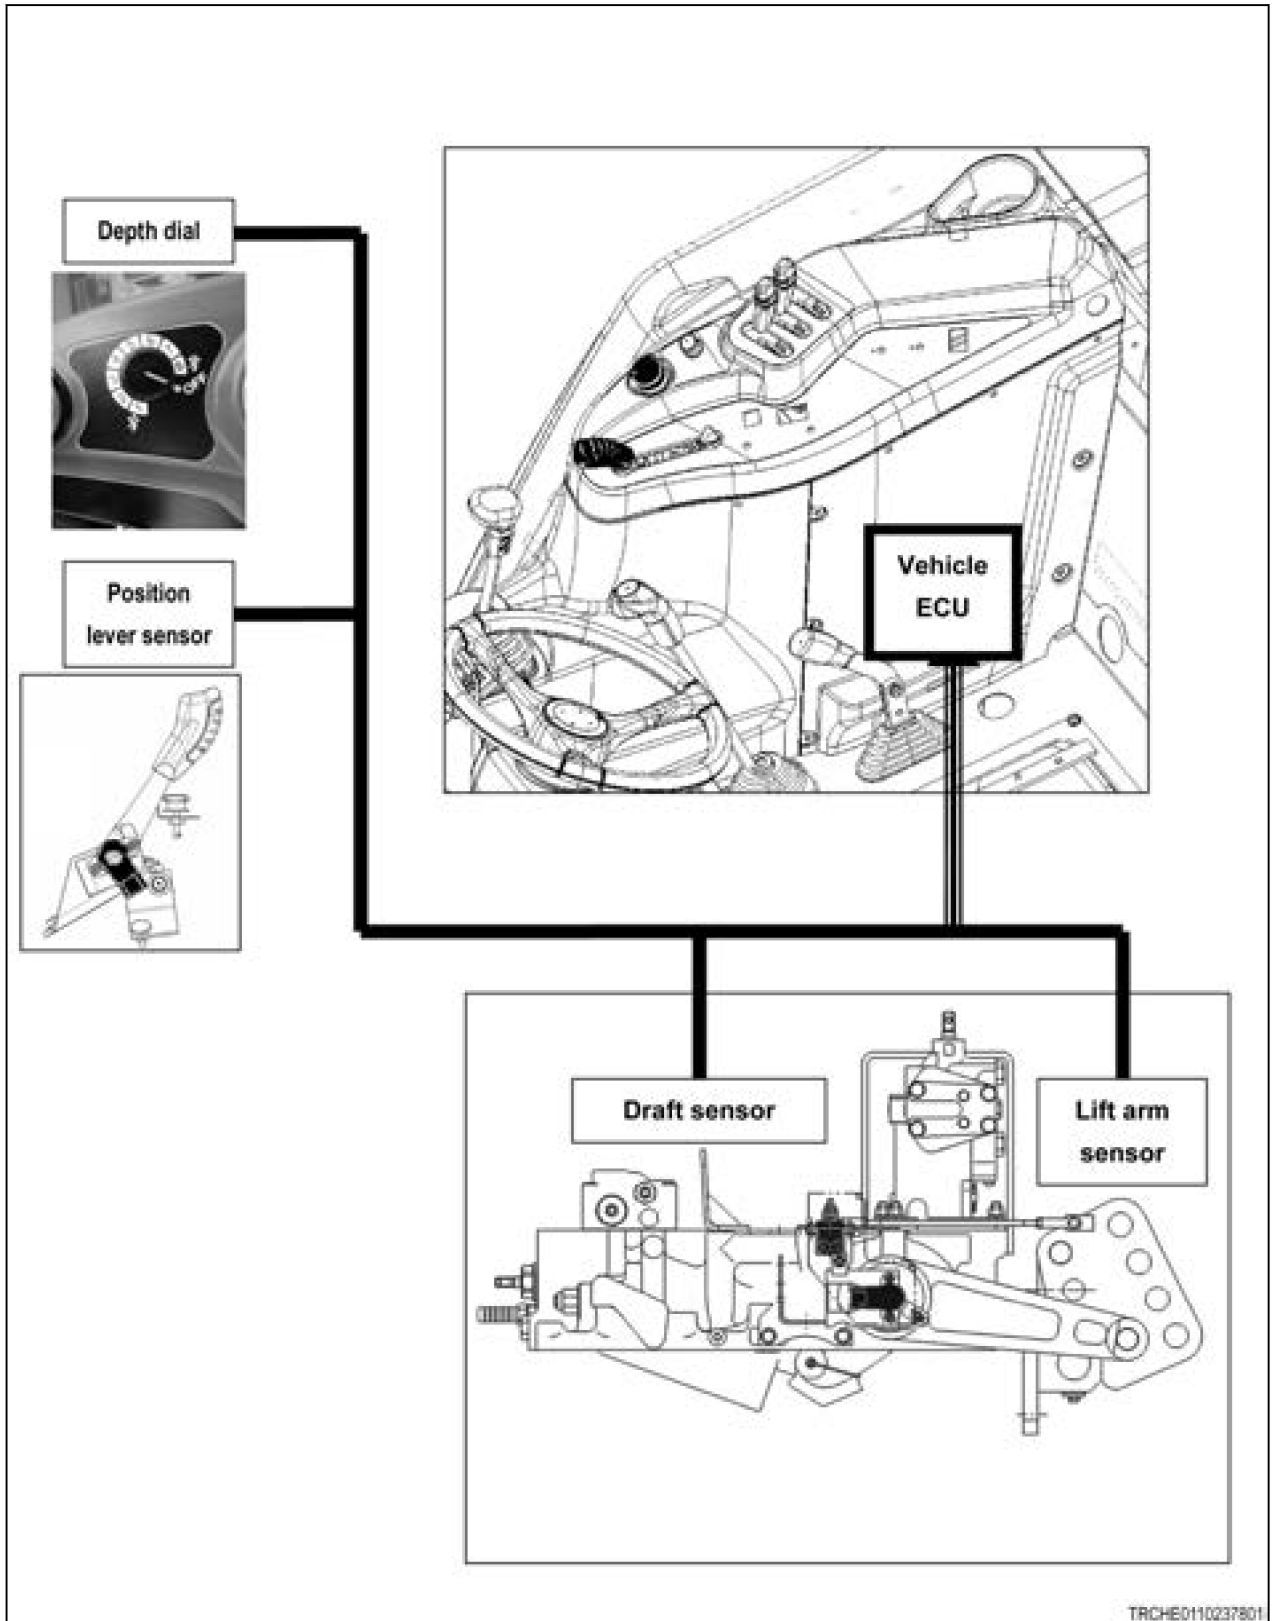
Fig. 86

Position lever sensor, lift arm sensor and draft sensor

- Short circuit in the 12V power supply line and signal line.
- Short circuit in the 5V power supply line and signal line.
- Sensor failure.
- Sensor mounting bracket needs adjustment.

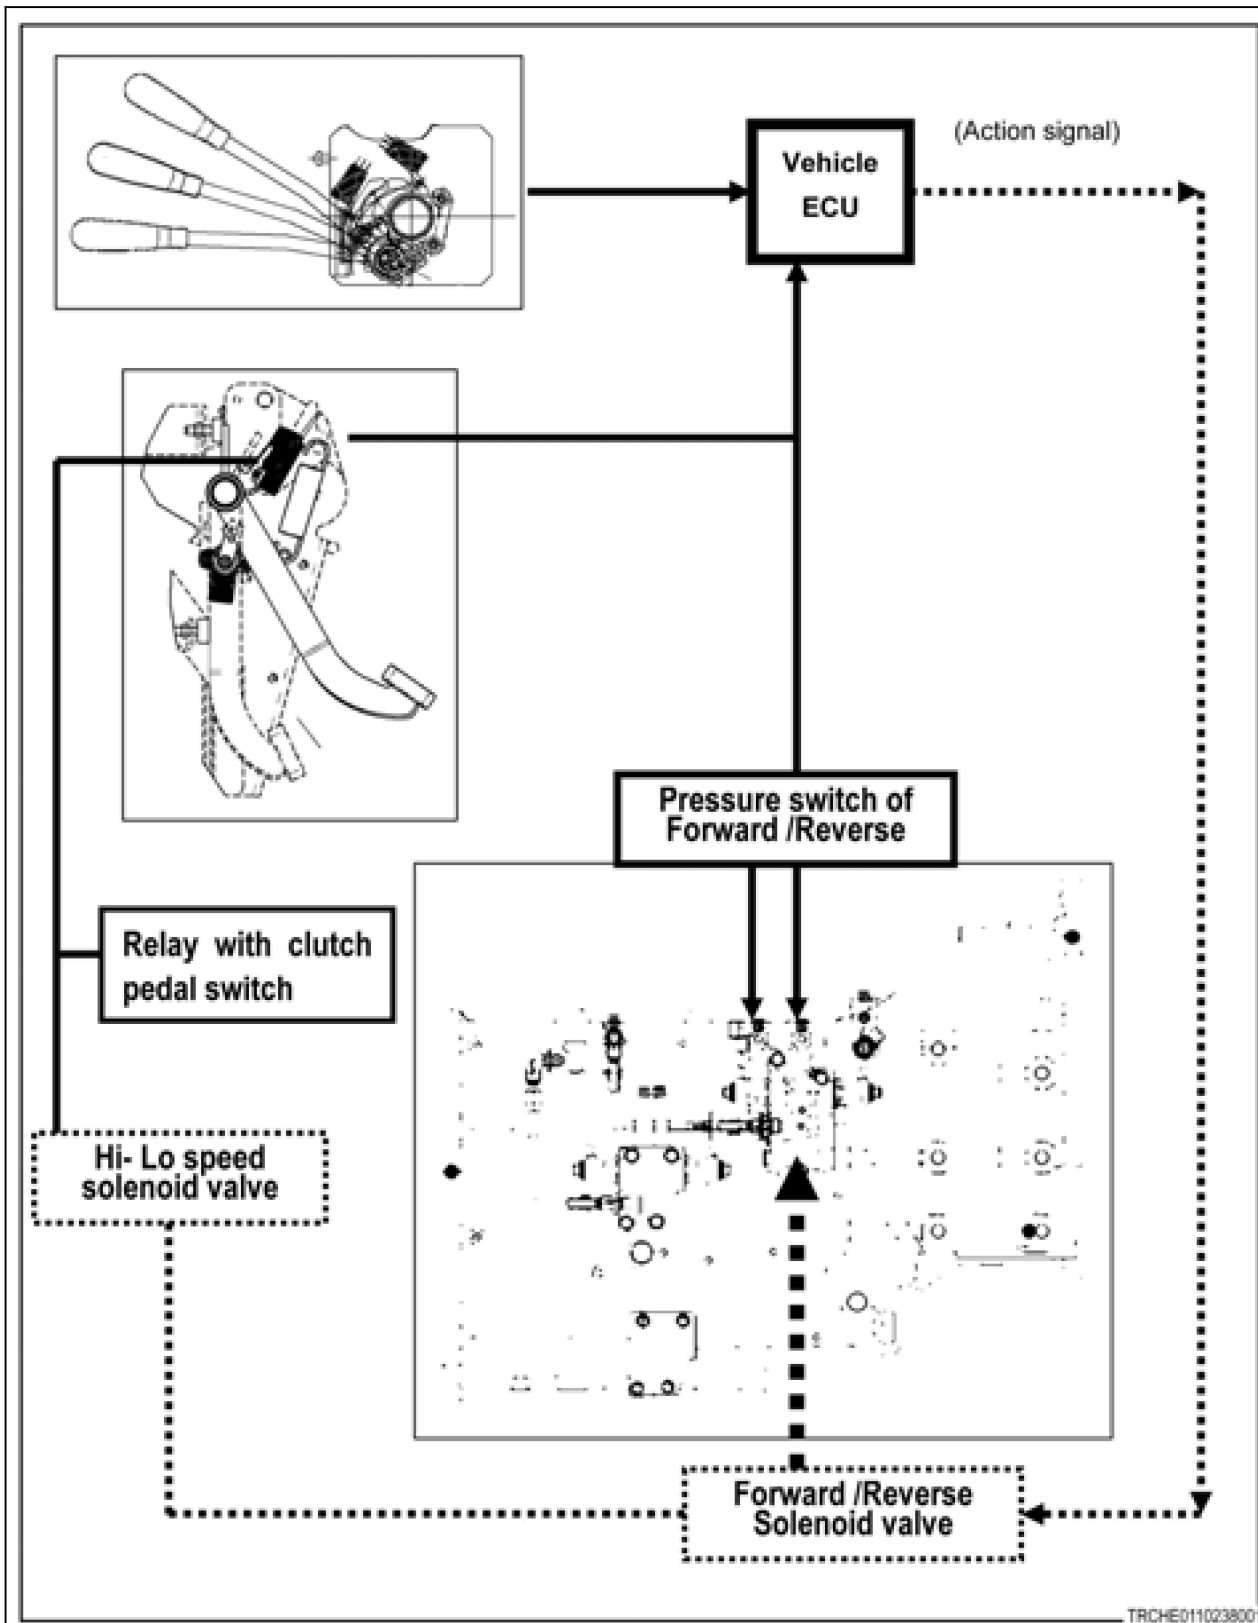
Fig. 101

**Pressure switch relay, solenoid valve function;
clutch pedal switch function**

- Clutch pedal relay has failed.
- Clutch pedal switch has failed.
- There is an open in the clutch pedal switch signal line.
- There is a short between ground and the clutch pedal relaysignal line.

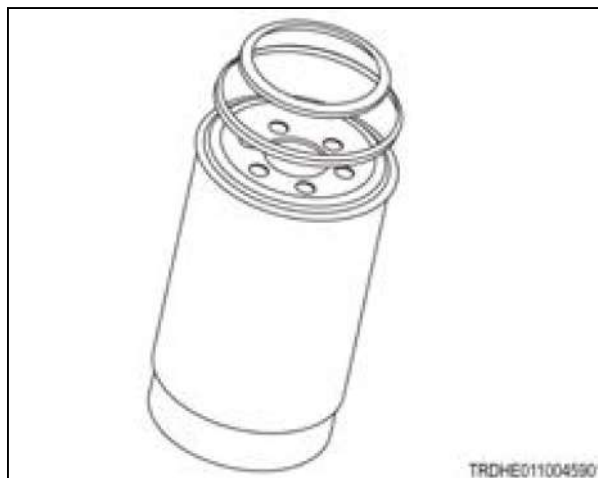
Fig. 7

Suction filter components

- (1) Engine
- (2) Main pump
- (3) Sub pump
- (4) Suction filter
