SERVICE MANUAL

CR6.80 / CR6.90 / CR7.90 /

CR8.90 / CR9.90

Combine

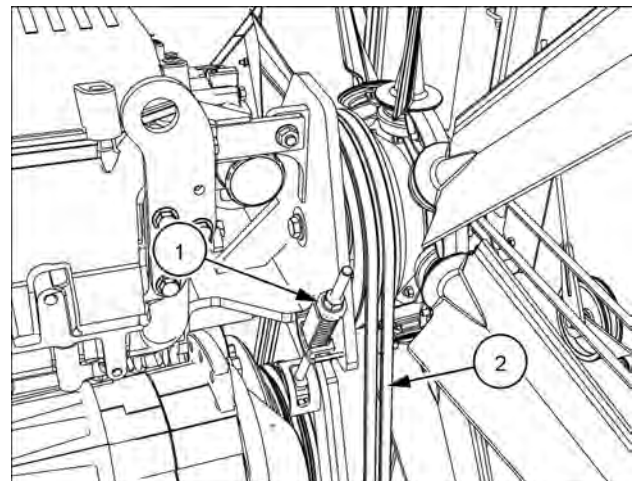
NHIL13CR00463AA 1

1. Loosen belt tensioner spring to the fan drive pulley by tightening the nut **(1)** (clockwise) until there is slack in belts.
2. Remove the fan drive belts **(2)** from the pulleys.

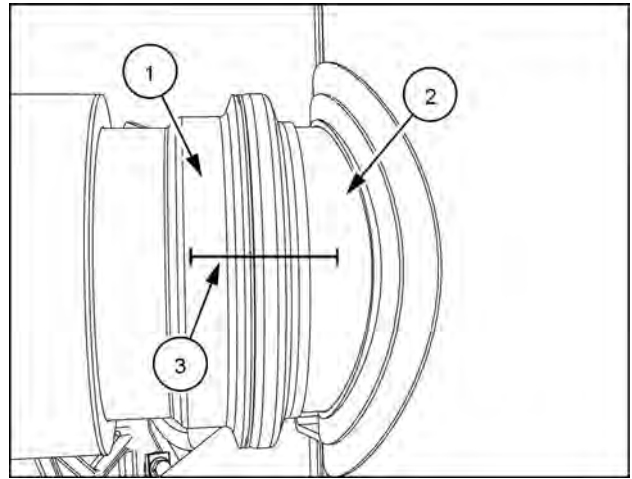
NHIL14AF00248AA 3

3. Position the mixer tube (1) to the Diesel Oxidation Catalyst (DOC) (2) and align to the horizontal mark (3) that was made during the removal process.

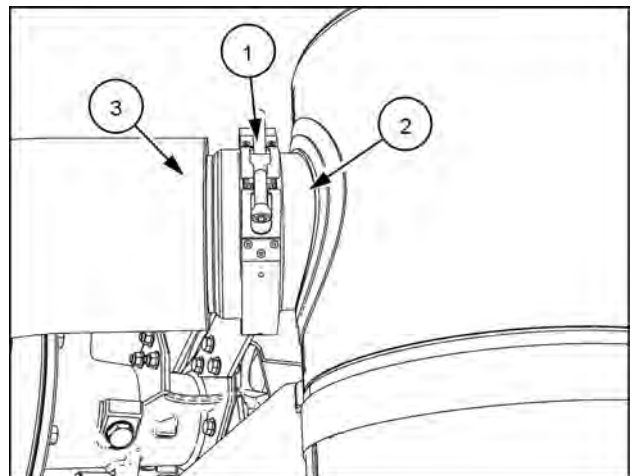
NHIL14AF00247AA 4

4. Install the tube clamp (1) to the DOC (2) and the mixer tube (3). Tighten the clamp to **12 N·m (106 lb in) ± 1 N·m (9 lb in)**

NOTE: It is recommended to install a new clamp and gasket.

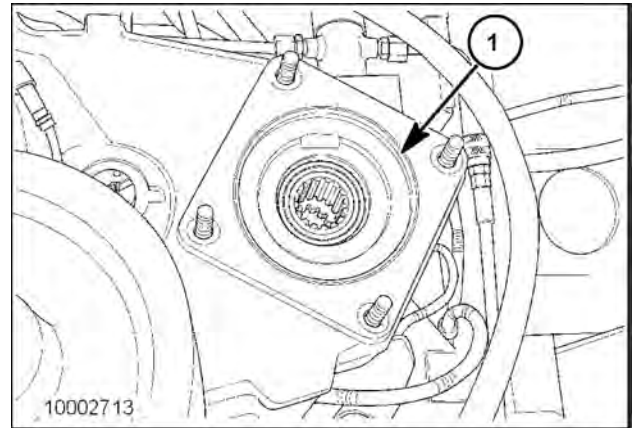
10002713 10

13. Remove the drive housing (1) from the gearbox.

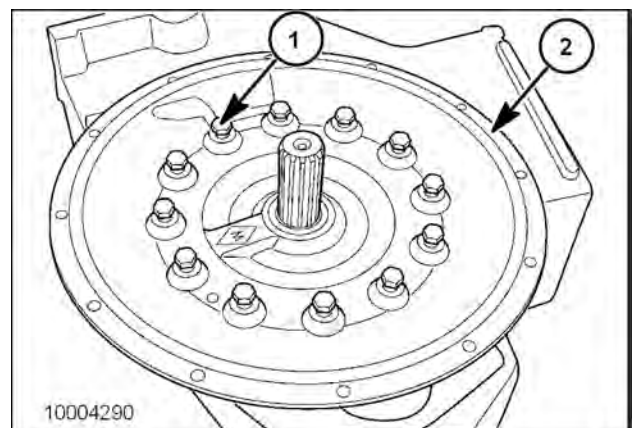
10004290 12

16. Remove cap screws (1) holding the engine flange onto the gearbox.
17. Separate the engine flange (2) from the gearbox.

NOTE: When removing the engine flange, protect the shaft seal against damage from the multi-spline profile of the spur gear shaft.

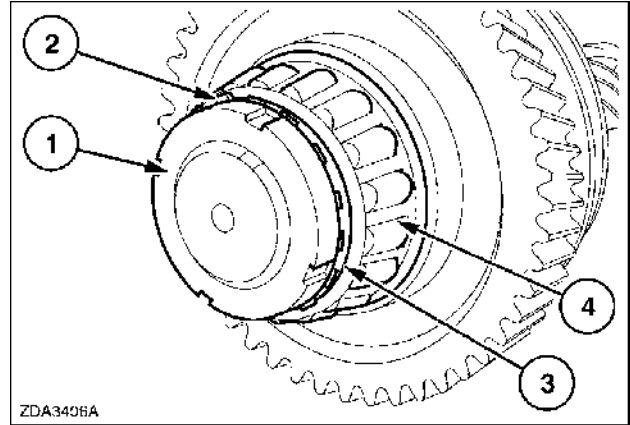
ZDA3406A 1

1. Unlock lock washer (2).
2. Remove nut (1) using **380001074**, lock washer (2) and washer (3) securing the bearing cone (4).

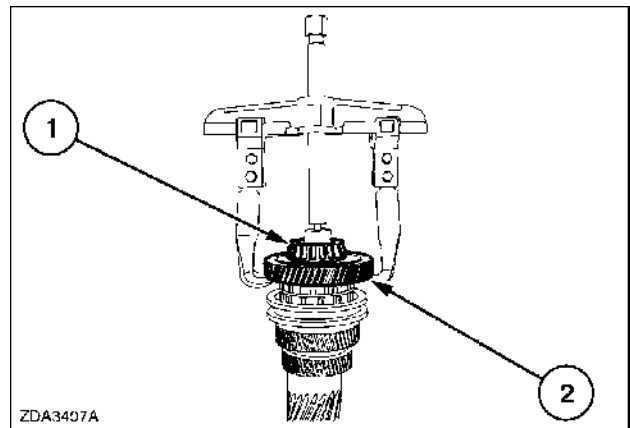
ZDA3407A 2

3. Remove gear (2) bearing (1) and the washer between the two parts with a puller.

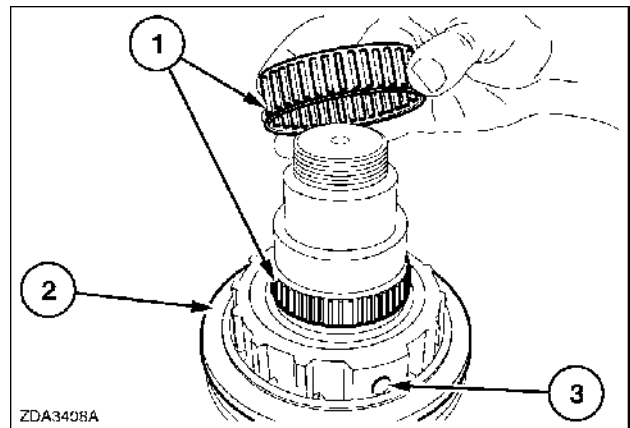
ZDA3408A 3

4. Remove needle bearings (1).
5. Remove selector ring (2) at the same time remove two balls (3) and the springs behind it.

NOTE: Balls (3) are spring-loaded, do not lose them.

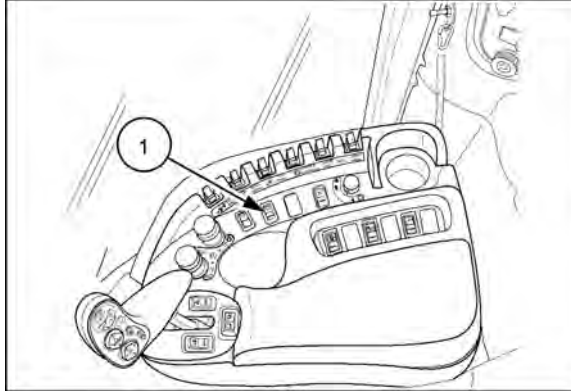
73074504 1

The powered rear axle (PRA) is available as a factory-installed or field-installed option. This system provides additional traction when the machine is operated in muddy or hilly field conditions. The system is engaged or disengaged electronically via the four-wheel drive engagement switch **(1)** switch on the right-hand console.

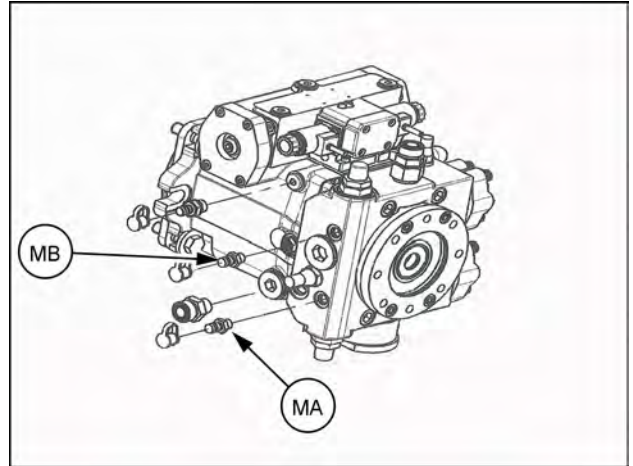
20075450A 9

Install pressure gauges (range **0-600 bar**) (**0-9000 psi**) to the hydrostatic pump test ports (**MA**) and (**MB**).

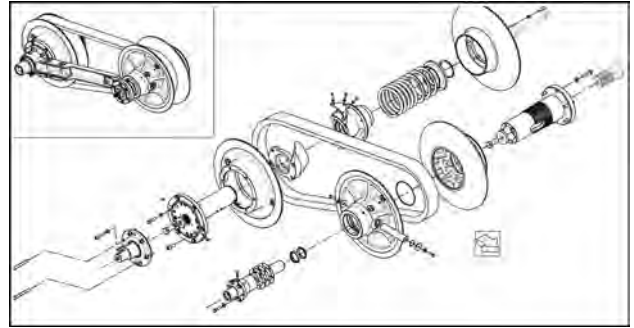
83117601A 1

- The rotor adjust valve varies the position of a plunger in the rotor variable sheave (variator).
- The plunger is a hydraulic cylinder that operates a floating disc within the variator assembly to alter the belt speed.

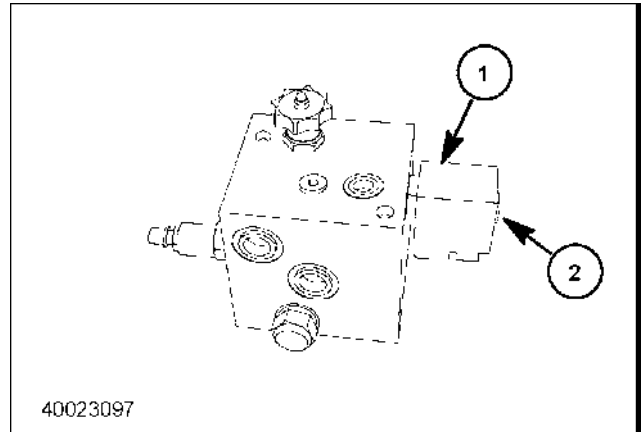
40023097 1

1. To replace the solenoid (1), remove the nut (2) and slide the solenoid off the valve shaft.
2. Install the new solenoid (1) and torque the nut (2) to **5 - 8 N·m (4 - 6 lb ft)**.

NOTICE: Do not over-torque the solenoid.

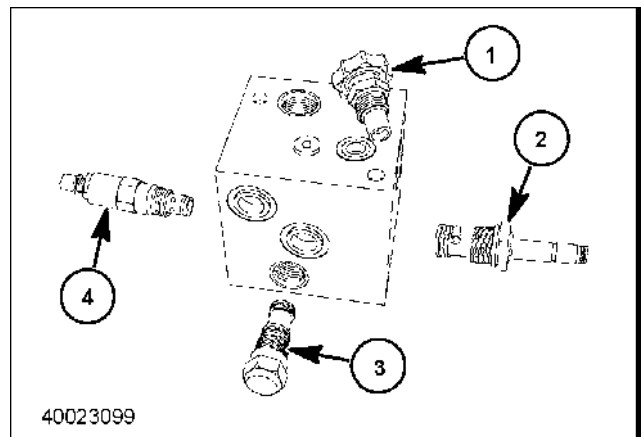
40023099 2

3. As necessary, replace the speed control valve (1), solenoid valve (2), check valve (3) and/or relief valve (4) by unscrewing them from the hydraulic block.

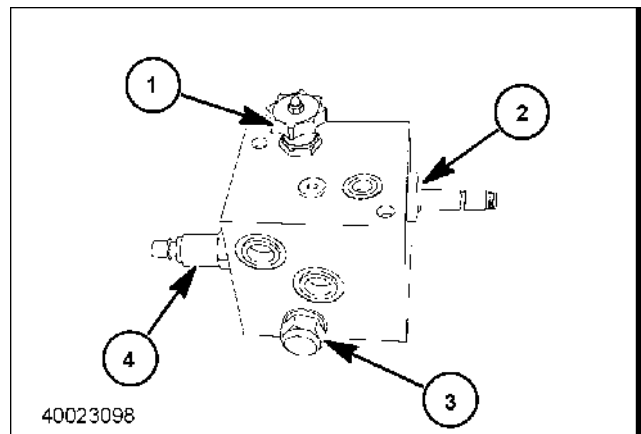
40023098 3

4. Make sure the O-rings are in good condition. Coat the O-rings with **NEW HOLLAND AMBRA MULTI G 134™ HYDRAULIC TRANSMISSION OIL** hydraulic fluid prior to installing any new valve in the hydraulic block.

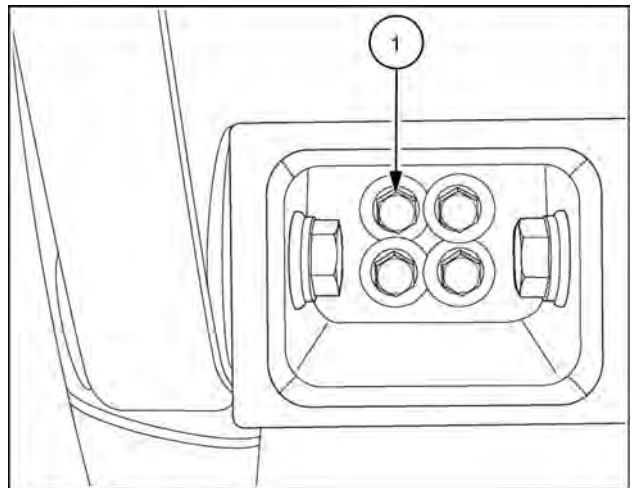
20085516 2

2. Remove the four M16 x 50 bolts and washers (1) from inside the idler tension axle pivot mount.

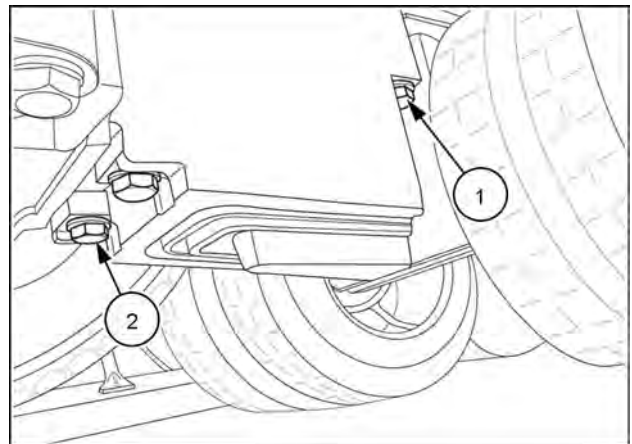
20085408 3

3. Remove the two M16 x 110 bolts (1) and two M16 x 180 bolts (2) from the isolator block.

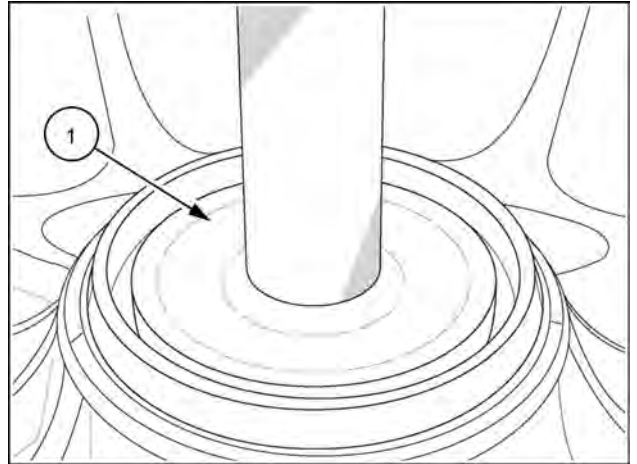
20085418 1

1. Use a 112 mm (4.41 in) diameter bearing driver (1) to install both bearing cups in the hub or wheel until they are seated firmly against the inner shoulder (2) of the hub or wheel.

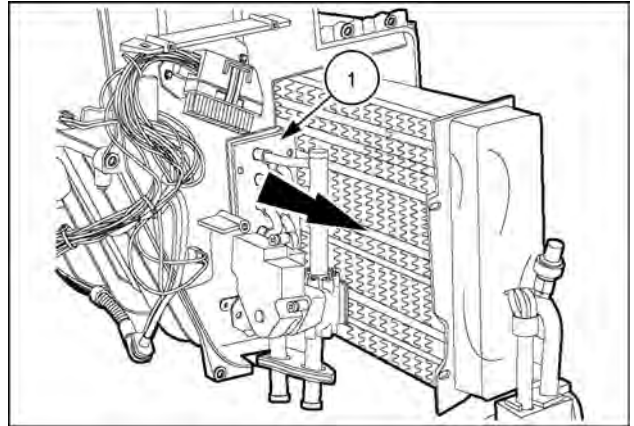
83082329 10

11. Pull the heater core assembly (1) from the housing.

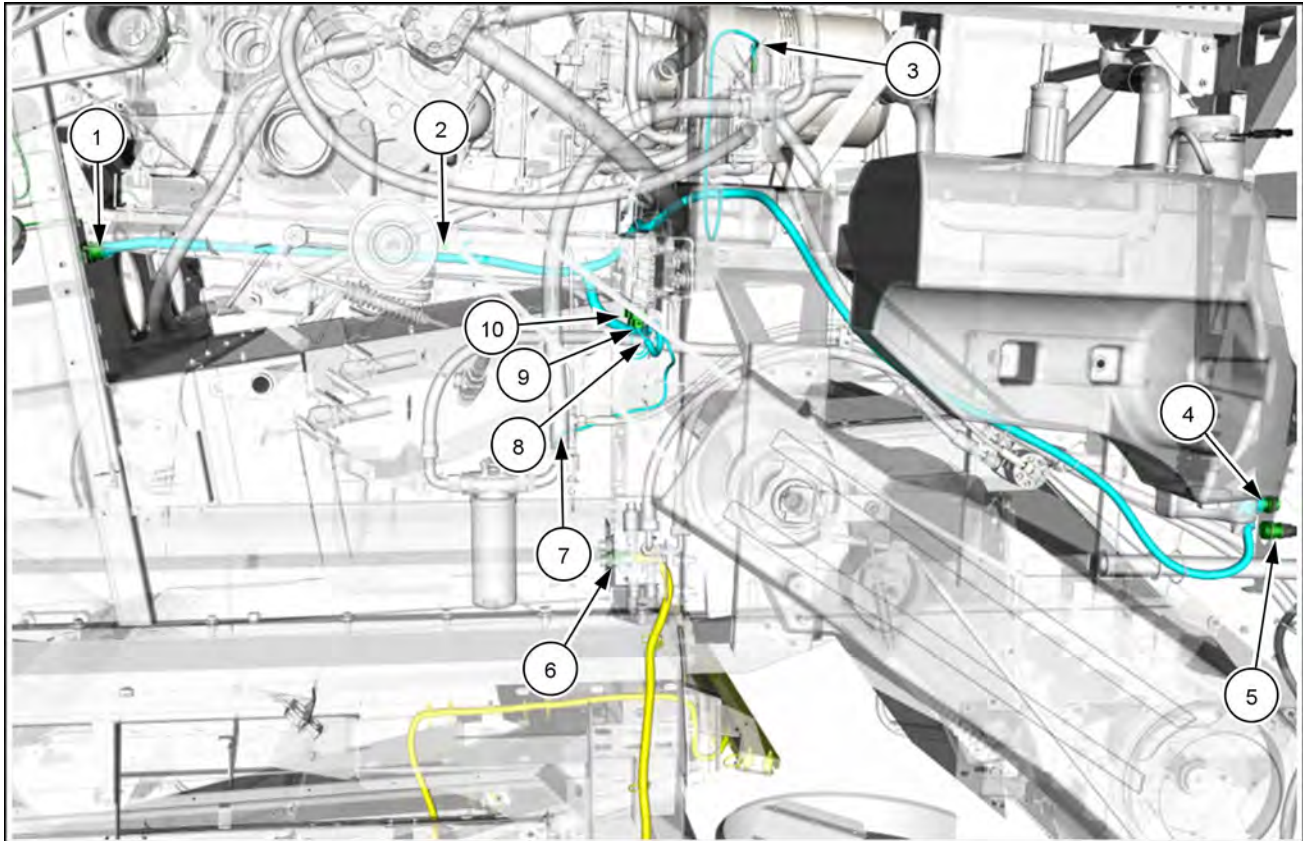
NHVM15CR00331JA 10

Item	Connector	Wiring harness	Description
(1)	X-1037	Straw Hood Option (SHO)	Straw hood option to expansion harness connection
(2)	X-563B	Straw Hood Option (SHO)	Engine to threshing ground GND-003
(3)	X-501PB	Straw Hood Option (SHO)	Opti-Spread™ RPM change solenoid Y-457
(4)	X-1038	Straw Hood Option (SHO)	Straw hood option to active spreading harness connection
(5)	X-1038	Active Spreader (AS)	Straw hood option to active spreading harness connection
(6)	X-1035	Lower Frame Rear (LFR)	Lower frame rear to straw hood harness connection
(7)	X-206	Straw Hood Option (SHO)	Active spreader filter bypass B-206
(8)	X-033CN3	Straw Hood Option (SHO)	H-Bridge 3 A-033
(9)	X-033CN2	Straw Hood Option (SHO)	H-Bridge 3 A-033
(10)	X-033CN2	Straw Hood Option (SHO)	H-Bridge 3 A-033

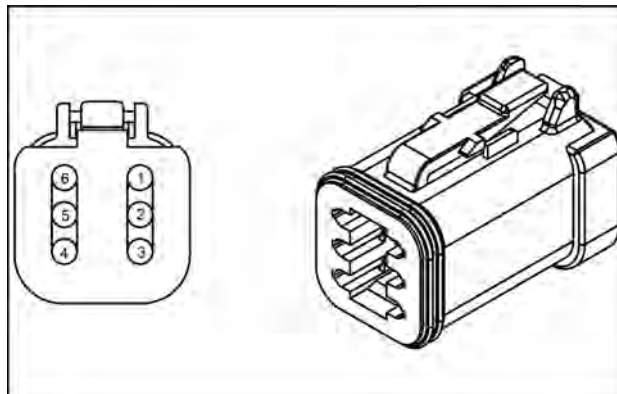
47416268 48

Connector X-1059EX. (47416268)

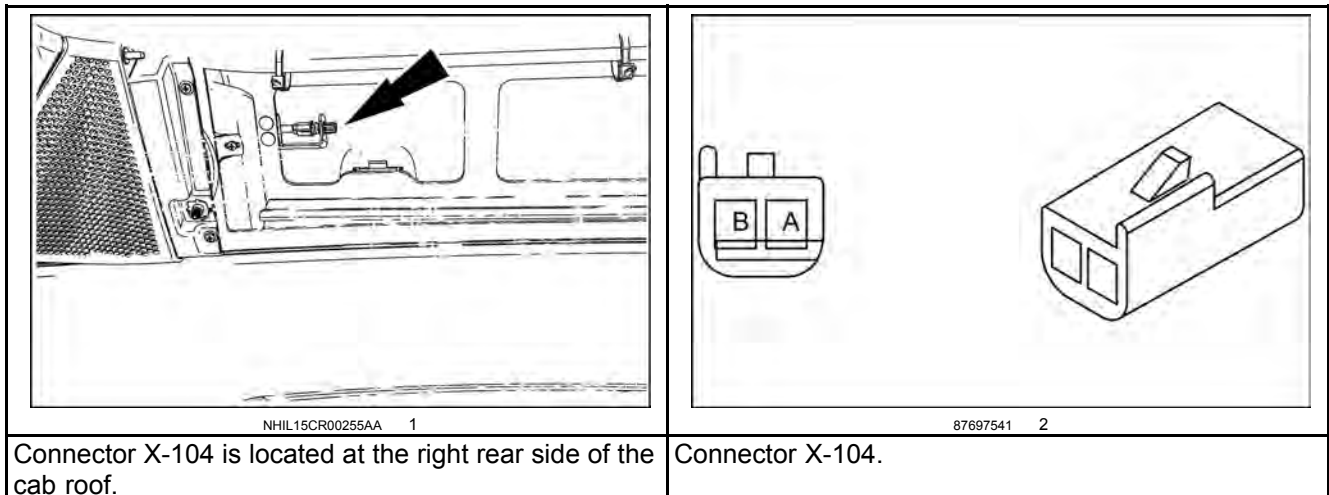
Disconnect the sensor from the Cab Roof Lower (CRL) harness at connector X-104.

Use a multimeter to measure the resistance at pins A and B.

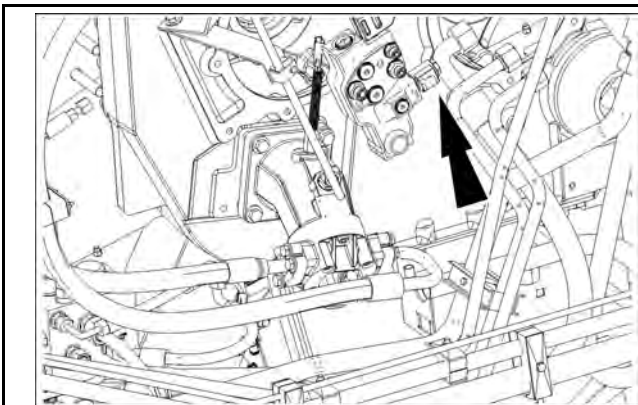
Disconnect the solenoid from the Gearbox Valves (GV) harness at connector X-448.

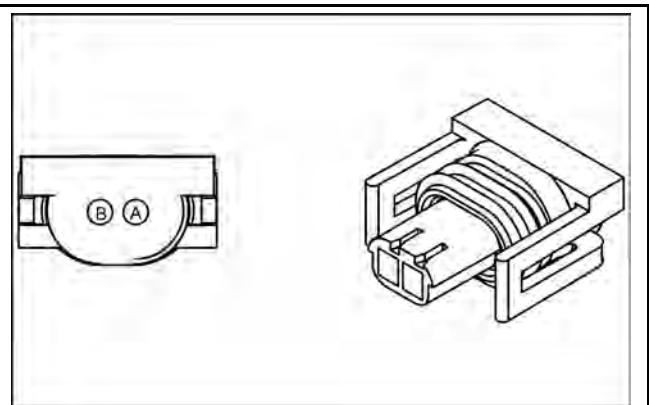
Connector X-448.

Connector X-448 is located on the left side of the machine.

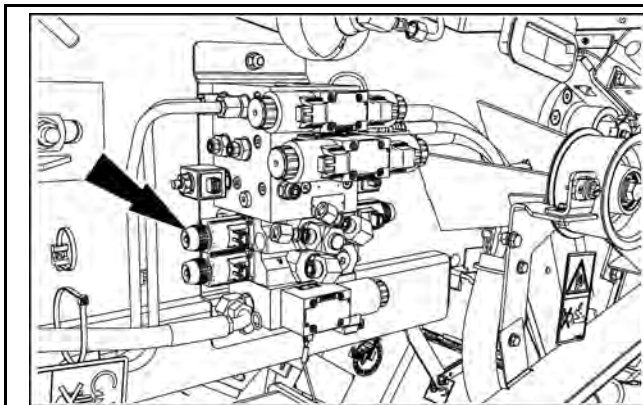
Disconnect the solenoid from the Short Feeder Valves (FV) harness at connector X-439.

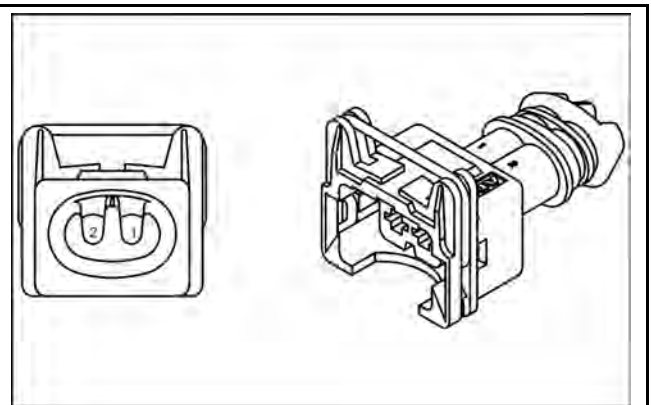
Connector X-439.

Connector X-439 is located on the left side of the feeder, on the valve block.

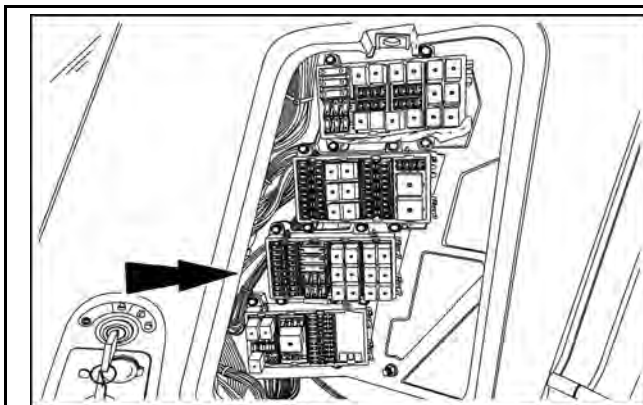
Disconnect the accessory relay K-027 from the Cab Main (CM) harness at connector X-903C.

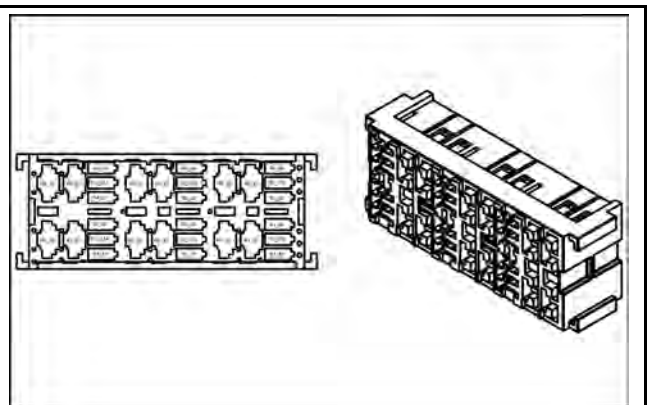
Connector X-903C.

Connector X-903C is located at the bottom of the fuse/relay panel.

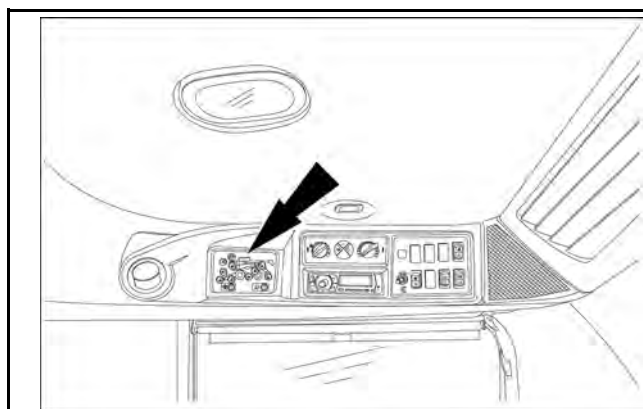
Disconnect the Cab Roof Lower (CRL) harness from the LCP at connector X-016.

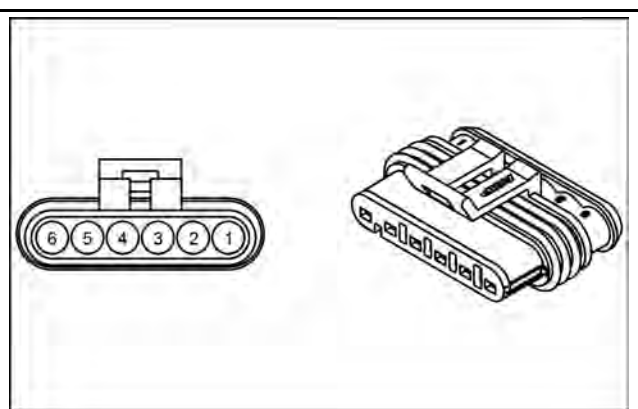
Connector X-016.

Connector X-016 is located on the overhead console.

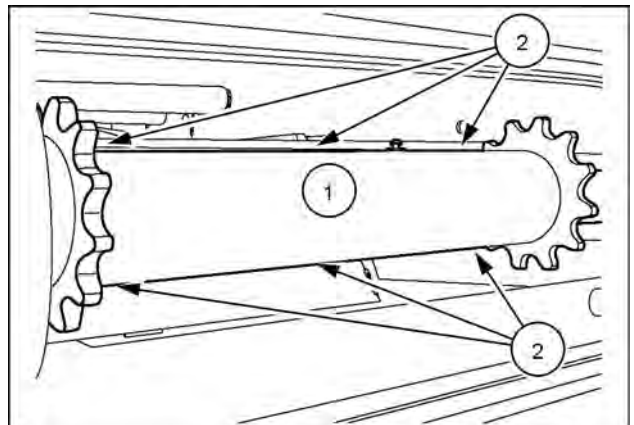
83090855 15

17. Install the two sets of anti-wrap shields **(1)** (one shown, left side). Each shield set is in two pieces, front and back. Each set is held in place by six M8 x 20 hex socket cap screws **(2)**, three on top and three on bottom. Apply **LOCTITE® 242** thread lock compound to the threads of the screws and tighten.

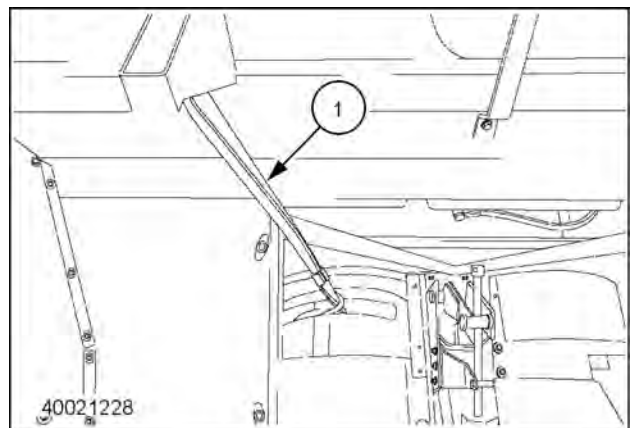
40021228

3. Remove the top rotor cover for the right rotor. Wrap a chain or lifting strap **(1)** around the rotor. Support the rear of the rotor by hooking the chain or tying the strap off to framework above the rotor.

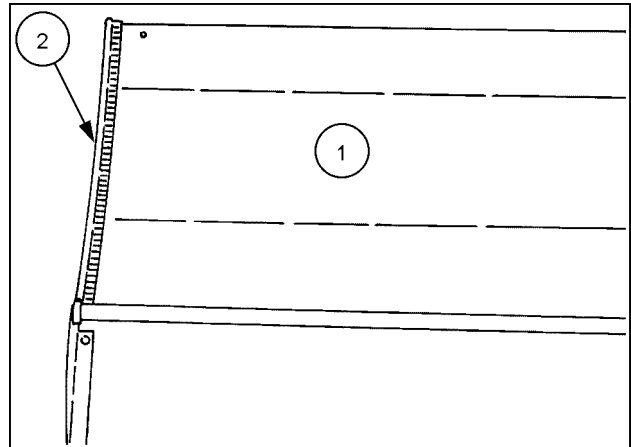
20023067 1

1. Inspect baffle (1) for damage. Replace as necessary.
2. Inspect rubber seal (2) on both sides of the baffle (1). Replace if worn or damaged.

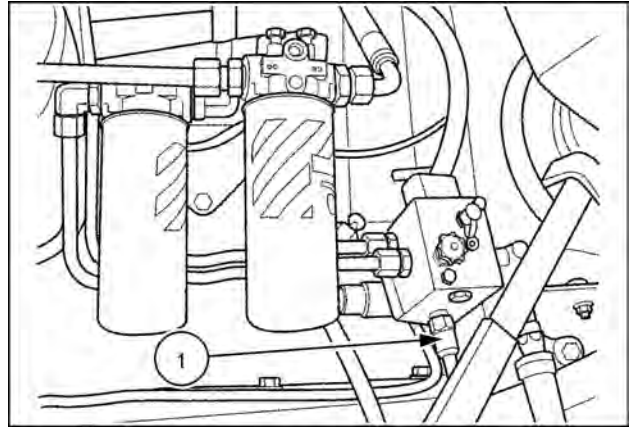
73076708 2

3. The reading on the pressure gauge should be approximately **200 bar (2900 psi)**. If the pressure gauge reading is not correct, replace the relief valve **(1)**.

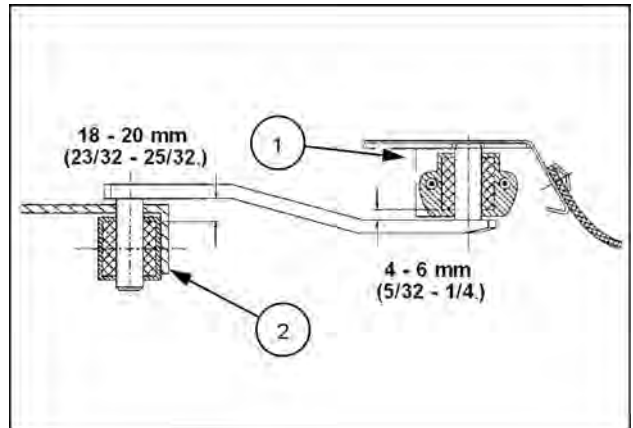
20013962_1222 3

3. Maintain a distance of **4 - 6 mm (5/32 - 1/4 in)** between the bottom of the bushing and the surface of the support arm.
4. Maintain a distance of **18 - 20 mm (23/32 - 25/32 in)** between the bottom of the bushing and the surface of the support arm.

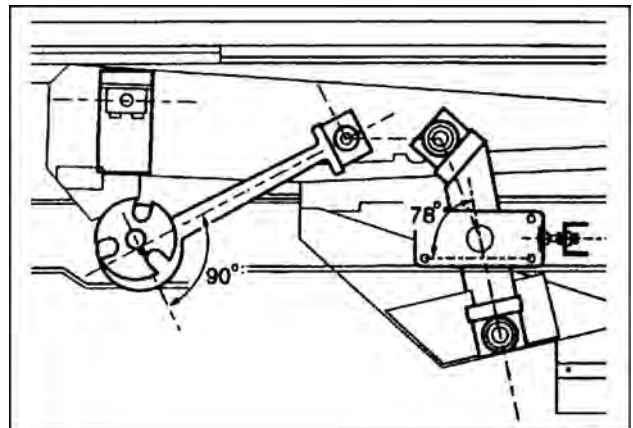
20013967_1224 5

7. Position the drive arms so that the keyway is perpendicular to the arm in the neutral position.
8. Tighten the bushing clamp hardware while holding the drive arm in the neutral position to the torque found in the standard torque chart.

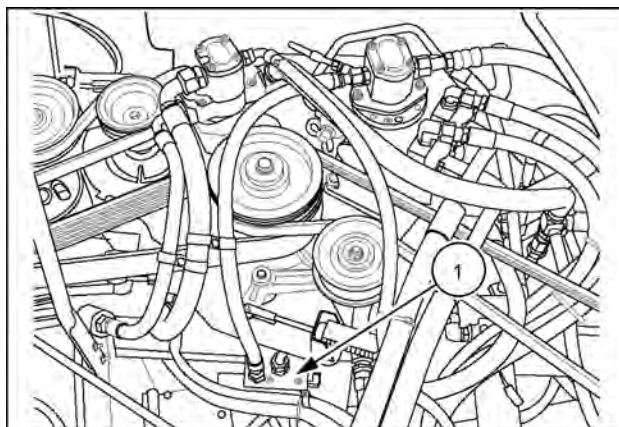
73076725 1

1. Locate the cleaning fan control valve (1) on the left-hand side of the combine..

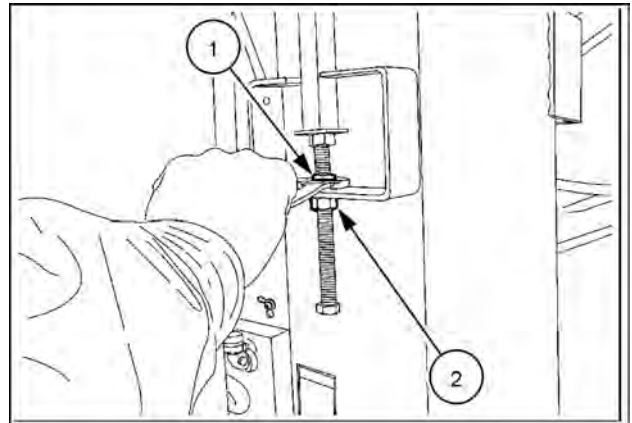
ZDA2922A 11

16. Adjust the grain elevator chain with nut **(1)** and nut **(2)** at the rear of the grain elevator.

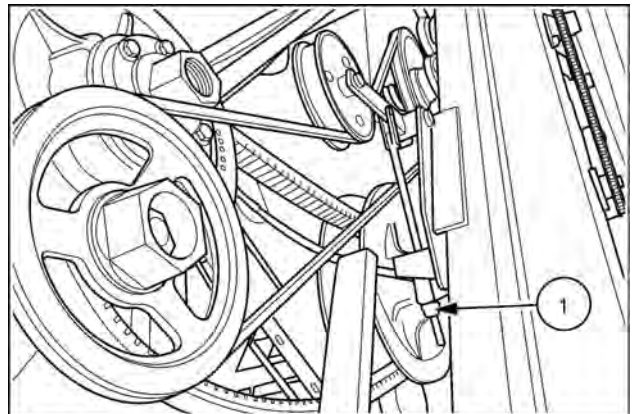
13020117 12

17. Adjust the grain elevator intermediate shaft drive belt tension with nut **(1)** to the specified length on the indicator plate on the adjustment rod.

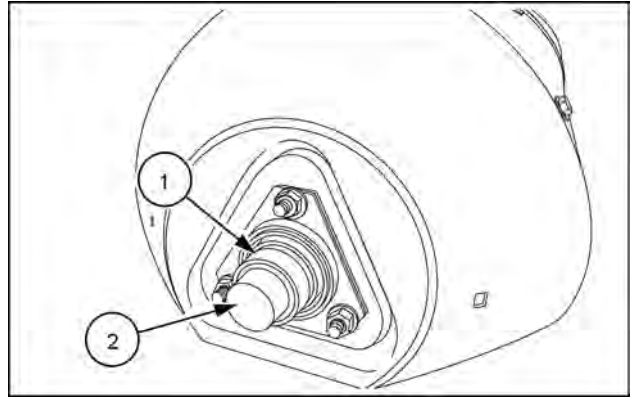
NHIL13AF01363AA 8

7. Loosen the lock collar (1) and adjust the auger (2) to the bottom against the gearbox hub.
8. Tighten the lock collar (1).

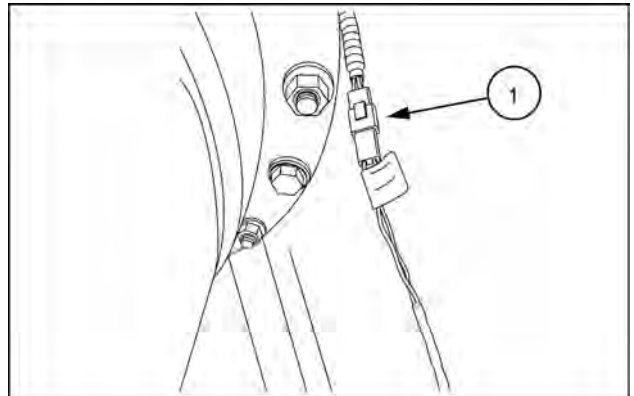
NHIL13AF01367AA 10

10. Connect unloading light wiring harness (1).

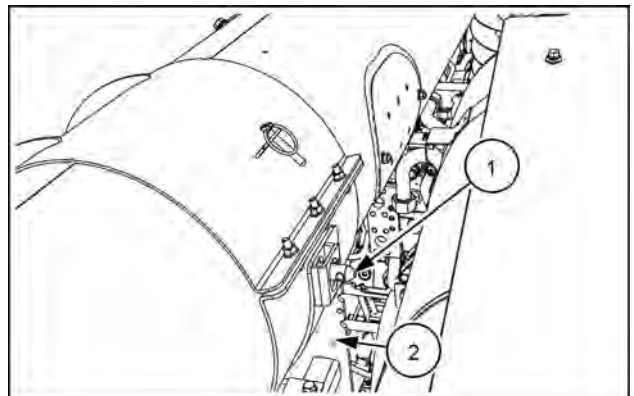
NHIL14AF01211AA 11

11. Adjust the band assembly as needed so that the pin (1) lines up with the mount (2) on the combine.
12. Tighten the hardware that secures the band clamp to **27 N·m (239 lb in)**.
13. Tighten all hardware to the torque found in the standard torque chart.
