RAYMOND SERVICE INFORMATION

RSI CTB-18-007
November 28, 2018

Models
4250 S/N 50501 Up w/5K TT Mast
All 4250 S/N 55501 Up w/TT Mast

SUBJECT: Carriage Stop Replacement

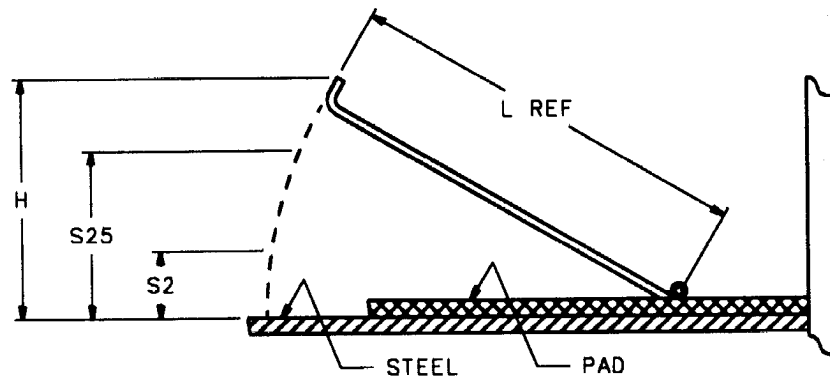
All measurements should be taken on the top lip of the deadman pedal from the steel floor of the operator's compartment. (See sketch below)

Adjust the length of the pedal rod so that the pedal height (H) and switch activations for S2 and S25 fall within the ranges specified below. In addition there should be a minimum of .5 inch travel left in the pedal when S25 deactivates.

L = 9.25	L = 13.87
H	4 - 4 1/4	5 3/4 - 6 1/4
S25	3 1/4 - 3 3/4	4 7/8 - 5 3/8
S2	1 1/4 - 2	2 - 3
